6.12.5 The Four Cases

6.14.5 Structural Response of the WTC Towers to Fire without Impact or Thermal Insulation Damage

Aircraft Impact Damage

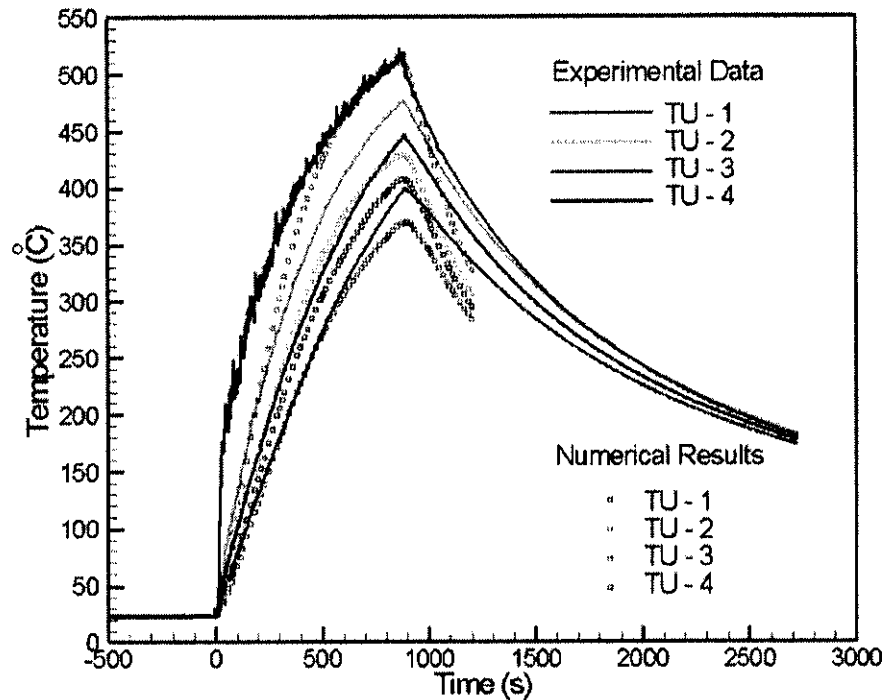
Figure 6–44 compares the measured and predicted temperatures on the steel surface of the top chord of a bare truss. Figure 6–45 is the analogous plot of the measured and predicted temperatures on the steel surface of the top chord of a truss insulated with 3/4 in. of BLAZE-SHIELD DC/F. Similar curves were generated for each of the steel pieces, bare and insulated.

Figure 6-44. Comparison of numerical simulations with measurements for the steel surface temperature at four locations on the top chord of a bare truss.

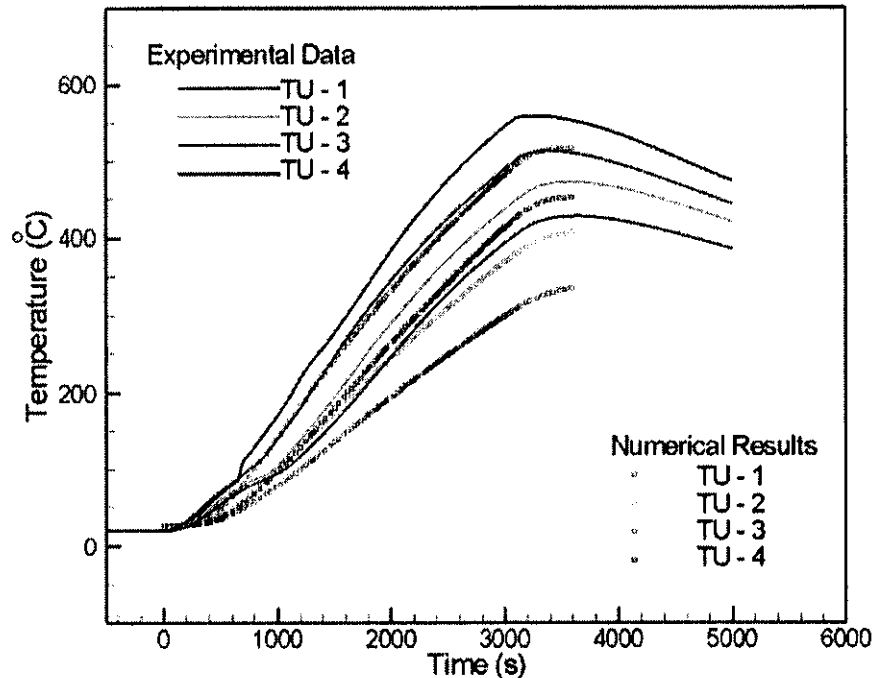
Figure 6-45. Comparison of numerical simulations with measurements for the temperature of the steel surface at four locations on the top chord of an insulated truss.

Examination of the graphs for the insulated steel pieces indicated the following:

- FSI captured the shape of the temperature rise at the steel surfaces and the significant decrease in the rate of temperature rise when the SFRM was present.
- The times to the peak temperature (or a near-plateau) were predicted to within about a minute in all cases.
- There was no consistent pattern of overprediction or underprediction of the surface temperatures.
- On the average, the numerical predictions of the steel surface temperature were within 7 percent of the experimental measurements for bare steel elements and within 17 percent for the insulated steel elements. The former was within the combined uncertainty in the temperature measurements and the heat release rate in the fire model. The increase in the latter was attributed to model sensitivity to the SFRM coating thickness and thermal conductivity.
